TRANSMITTAL LETTER FOR CARBON MONOXIDE, OXYGEN AND CARBON DIOXIDE
STRIP CHART DATA FROM DECEMBER VERIFICATION TEST BURNS NCBC GULFPORT
MS
9/18/1987
IDAHO NATIONAL ENGINEERING LABORATORY

TRANSMITTAL OF CARBON MONOXIDE DATA DJH-15-87

VERIFICATION TEST BURN
STACK GAS DATA
NCBC FULL SCALE DEMONSTRATION PROJECT

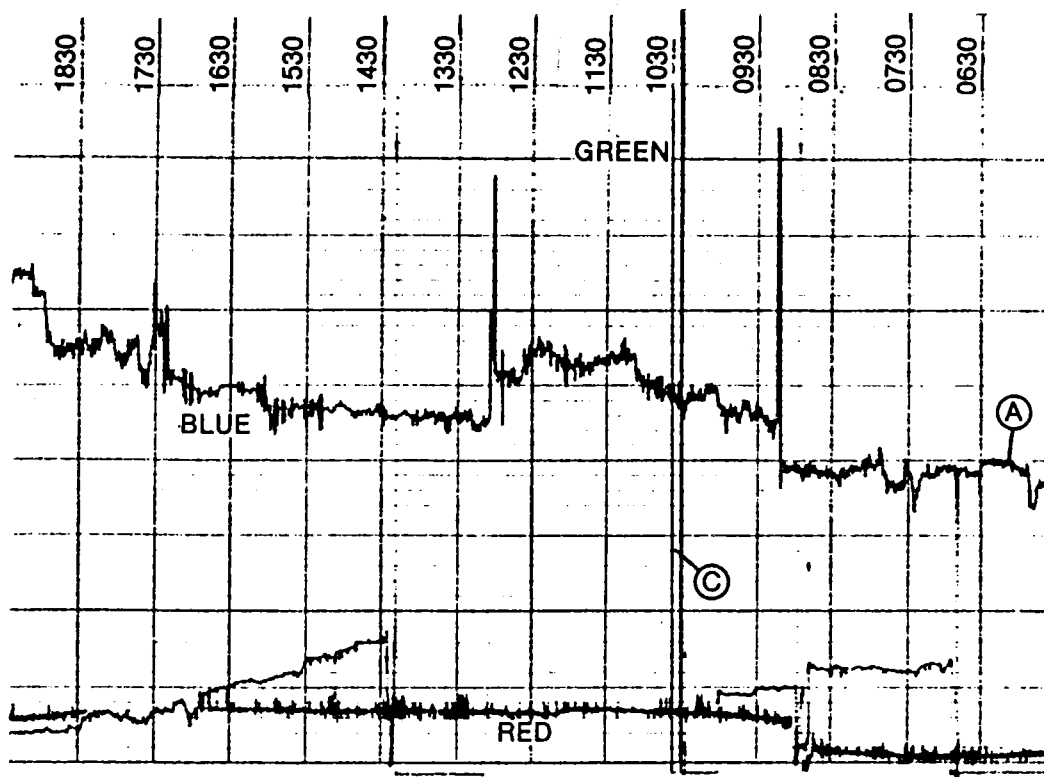
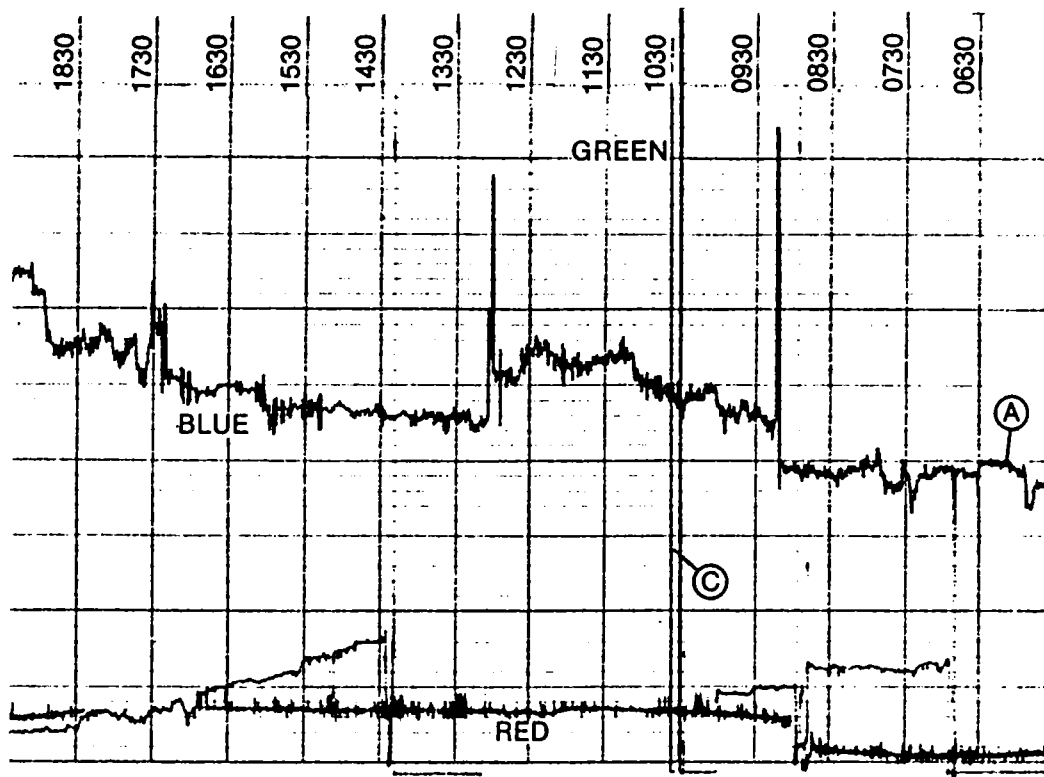
Dec. 6th, 1986

- A. O₂ infiltration into the sampling system was due to a leaking sample cooler. Oxygen was infiltrating the sample system and causing abnormally high O₂ measurements. The problem was solved on the morning of December 7 by bypassing the sample cooler. At the same time, a broken wire to the Isaac 5000 data logging system was causing intermittent problems with the computer O₂ data logging. This problem was repaired on the night of December 6.

- B. The oxygen infiltration problem was solved on December 7 thus resulting in corrected oxygen readings
- C. CO₂ analyzer failure. The carbon dioxide analyzer failed on December 6 due to moisture infiltration into the sampling system caused by the same leaking sample cooler as mentioned in "A" above.

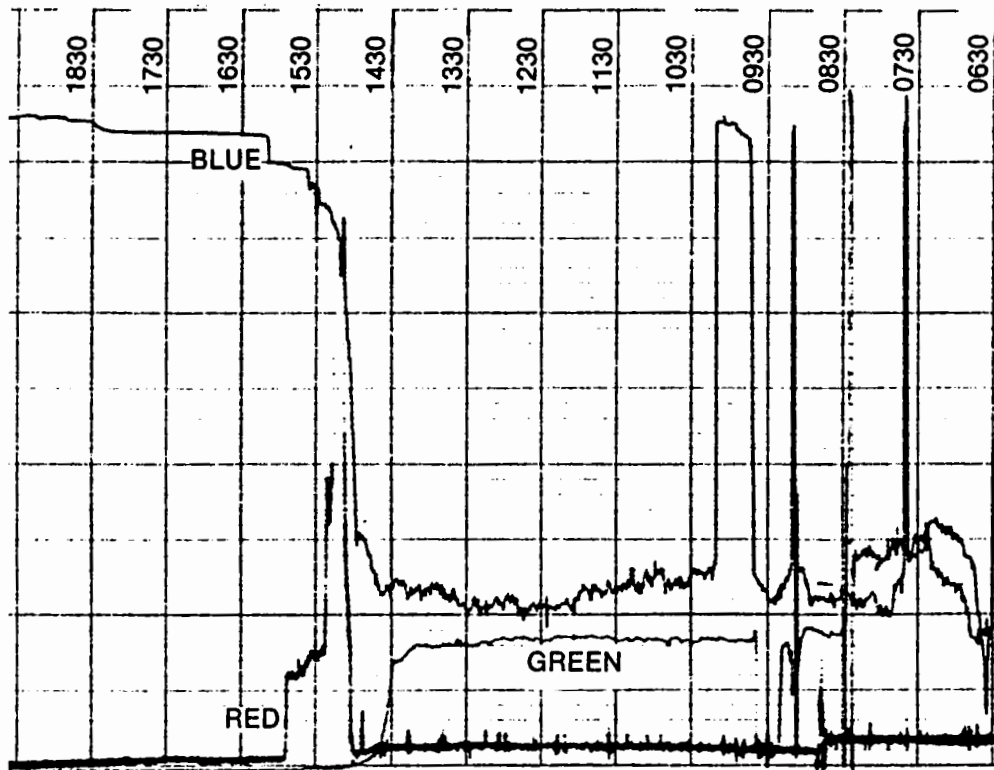
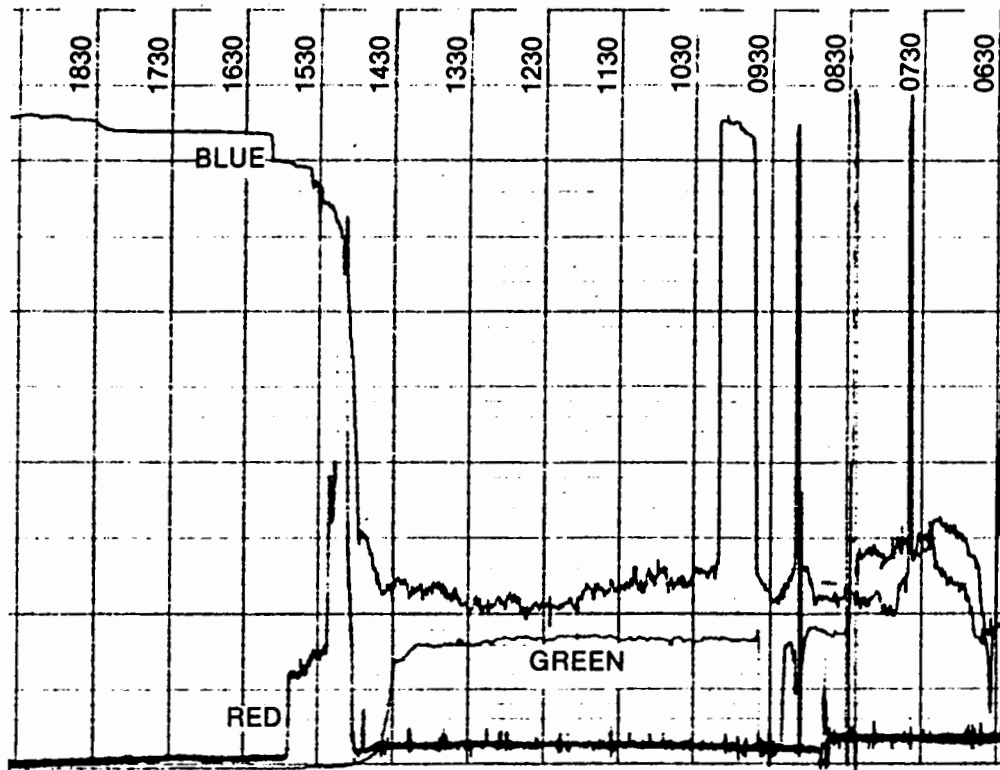
Dec. 15th, 1986

- D. The operations log book indicated three occurrences of a loss of secondary combustor flame at approximately 14:30.
- E. At 16:05 a flame out condition occurred in the secondary combustor.
